Testing of an LRS on a grinding mill: Typical Results

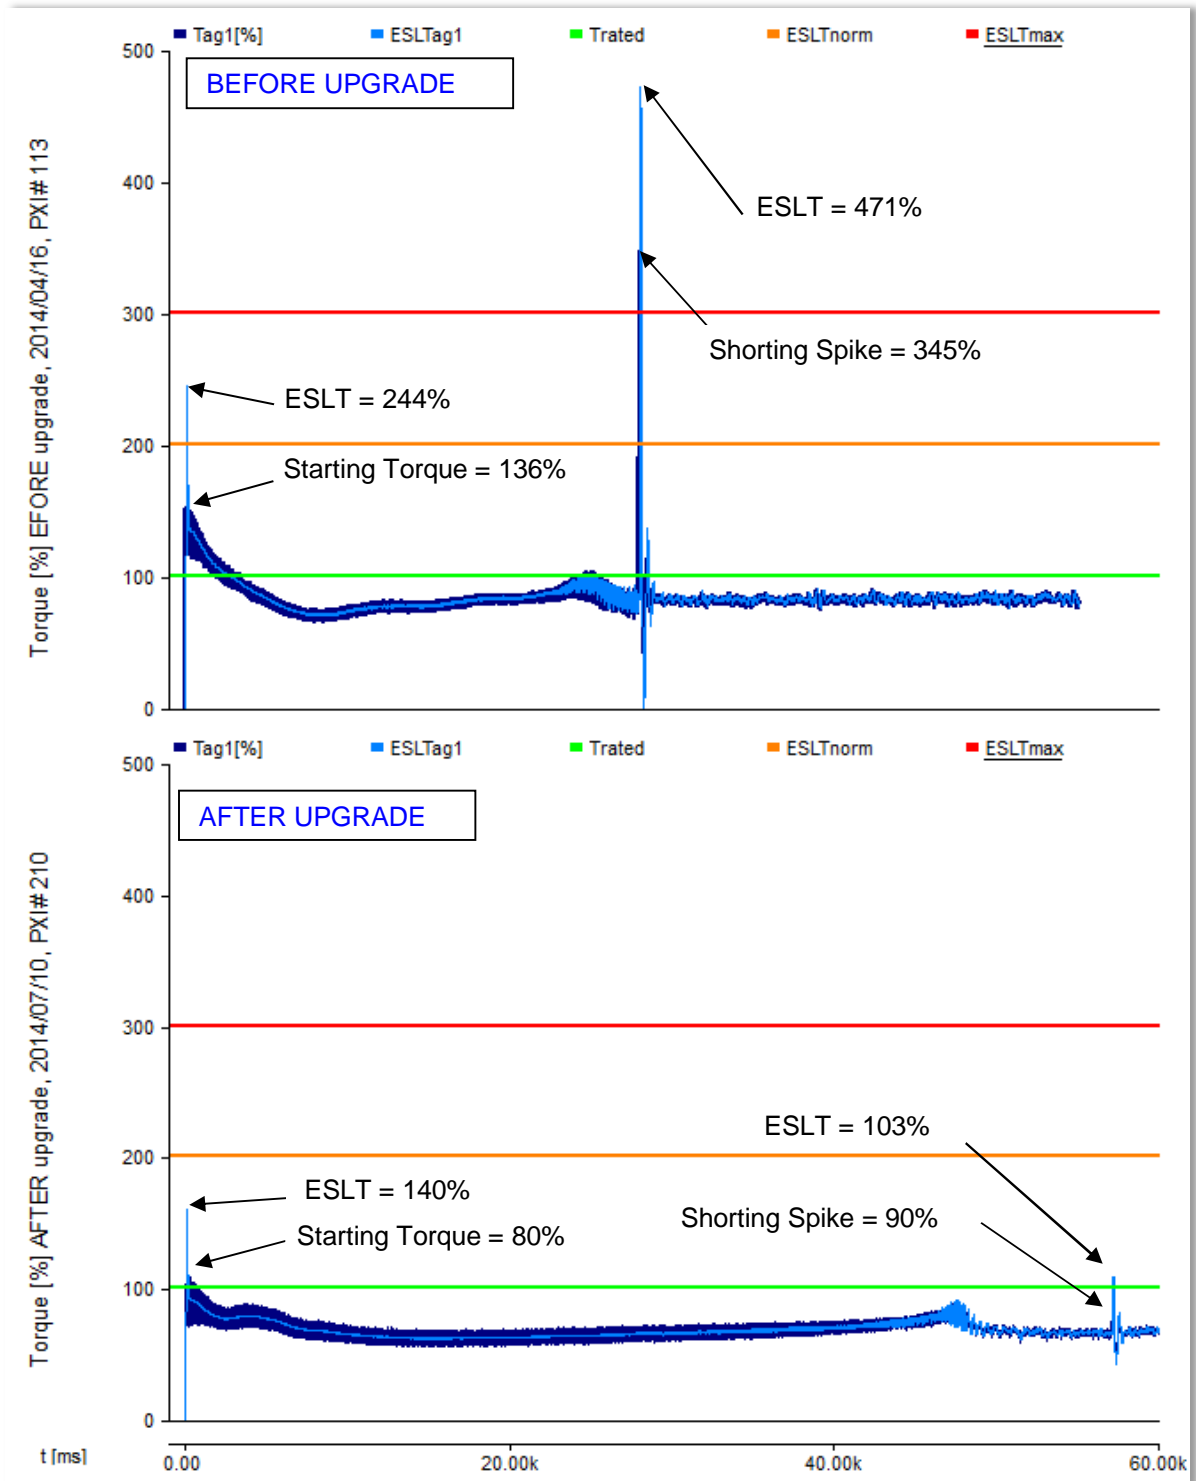
1. Torque Trace Before and After upgrade

[ESLT-Equivalent Shock Load Torque]

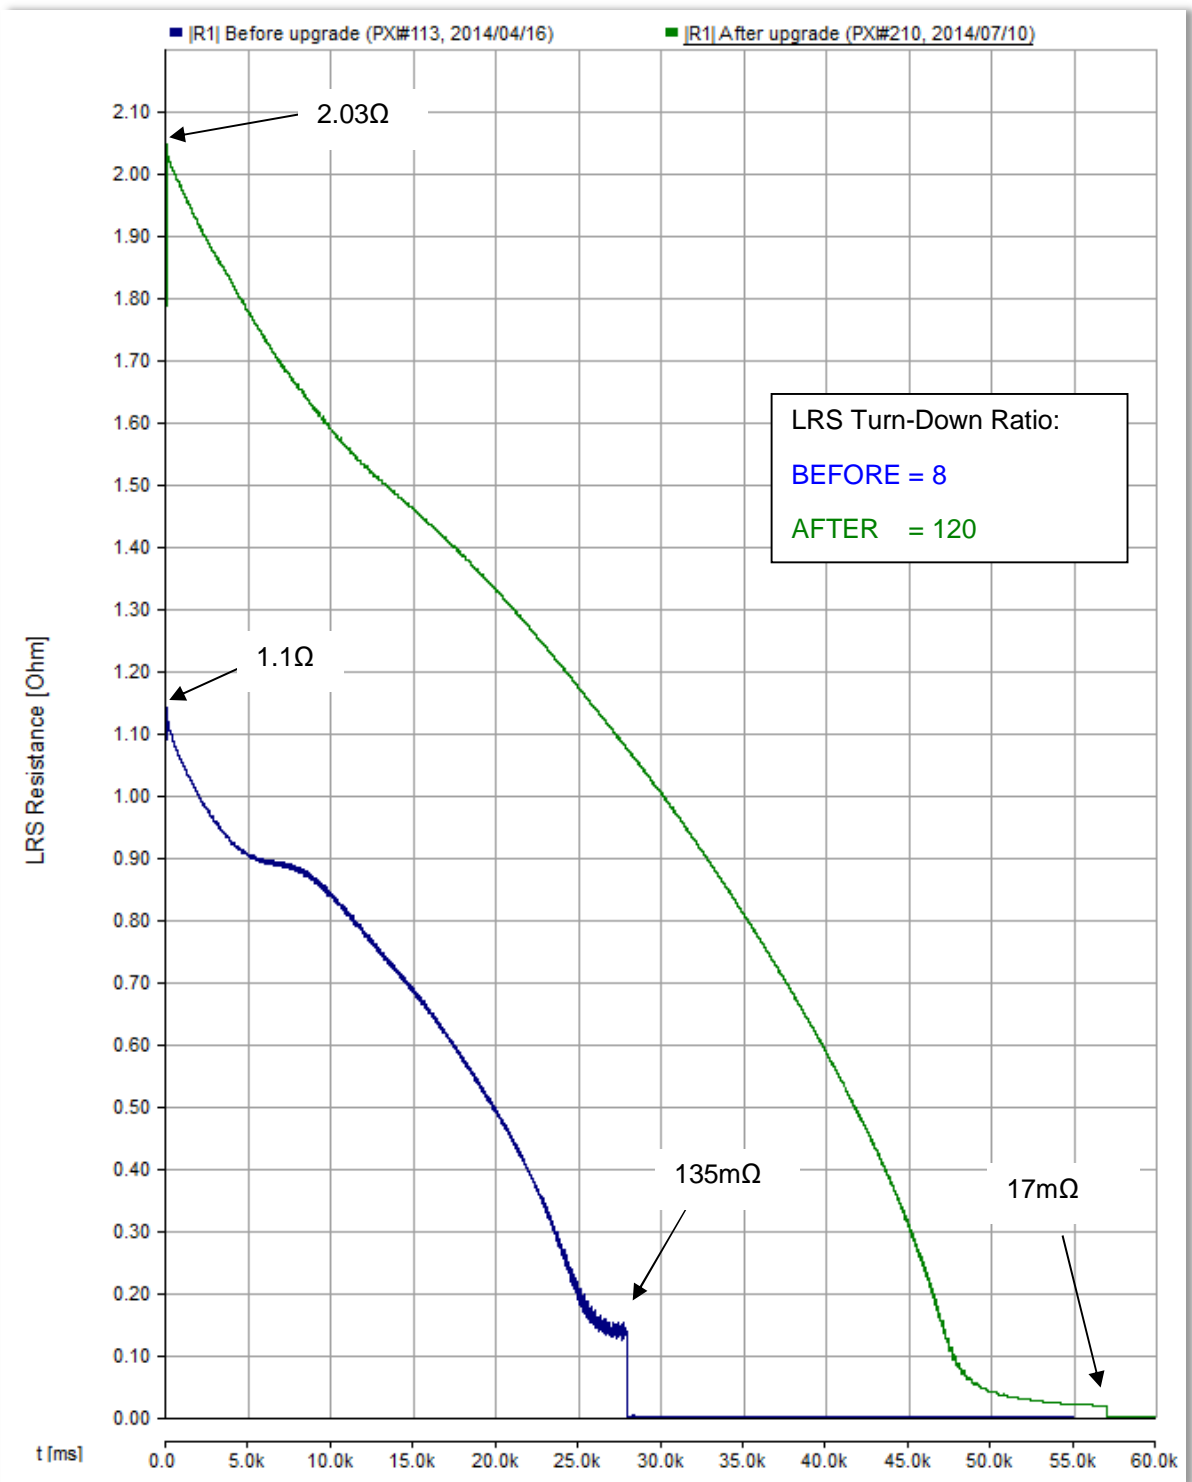
2. LRS Resistance Plot Before and After upgrade

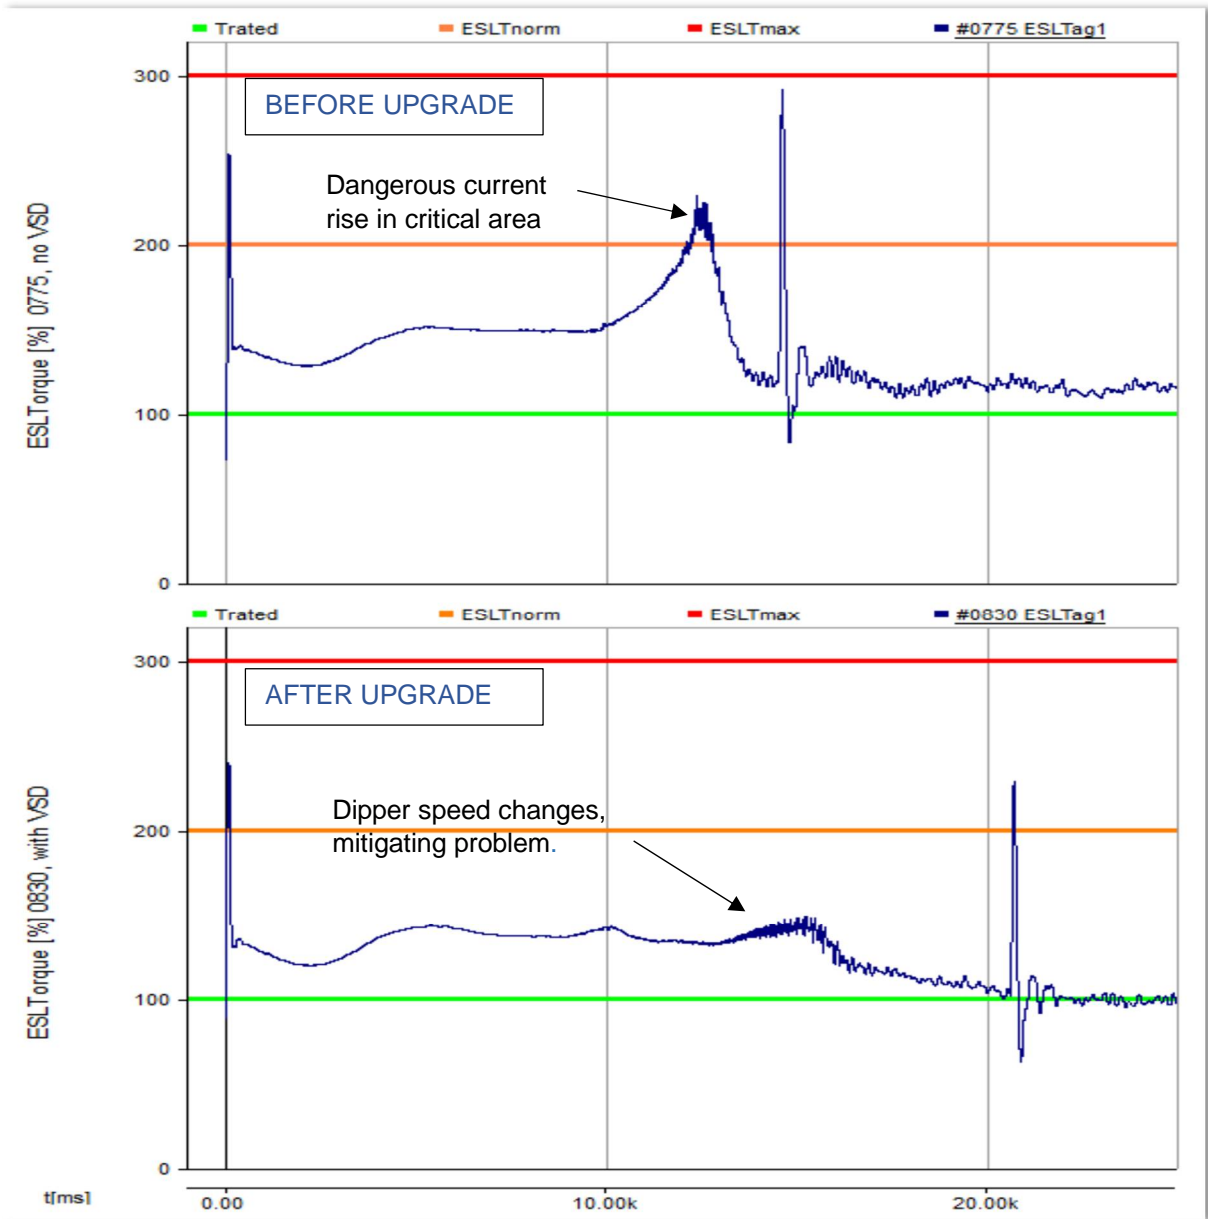
3. Current rise in critical area
